Test Report

Report No. : KR-16-00105XA : 1 OF 6 Page No.

Power Stone combined multi-slot board

Standard Counterweight

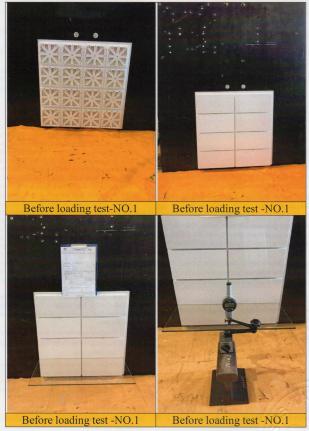
Test Photos:

Sample Number	Loading Test		
	Load(kg)	Deflection(mm)	Visual Inspection
No.1	20	4.923	The Standard Counterweight and the Combined multi-slot board were not fallen.  The glass was not broken.
	40	10.091	
	60	13.448	
	70	15.563	
	80	18.249	
	90	21.327	
	100	25.681
